# **Codes and Standards Analysis**

**Dr. Michael R. Swain  
Eric Grilliot  
Patrick Filoso  
Dr. Matthew N. Swain  
University of Miami  
Coral Gables, FL 33124**

## **Abstract**

The following report contains work on three separate tasks. They are as follows:

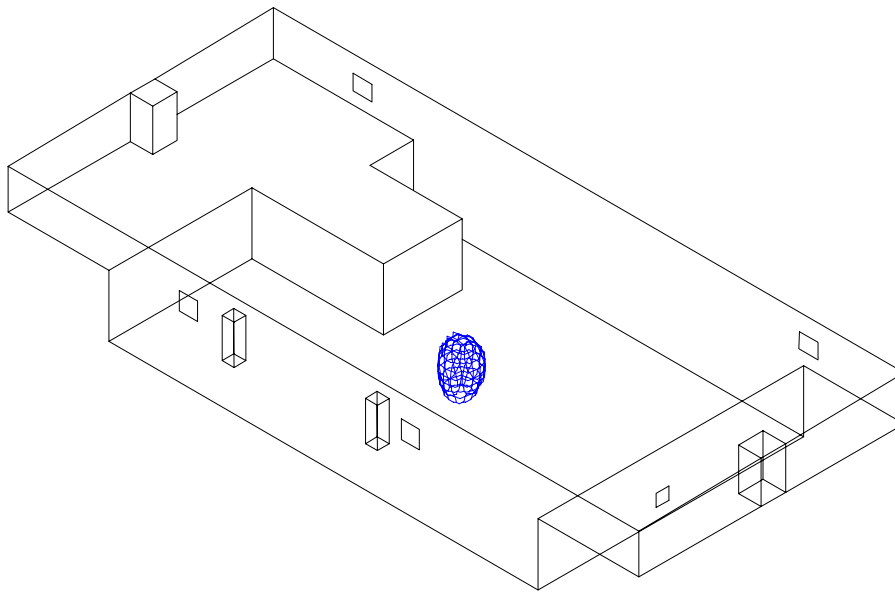
**Figure B 7 - Instantaneous release, 8 cubic feet of hydrogen, 1% concentration after 1 second**

Figure B7 and B8 show the position of hydrogen at 1.0% and 4.1% concentration one second after an instantaneous release of 8 cubic feet. The clouds are similar in size because there has been little diffusion in the first second.

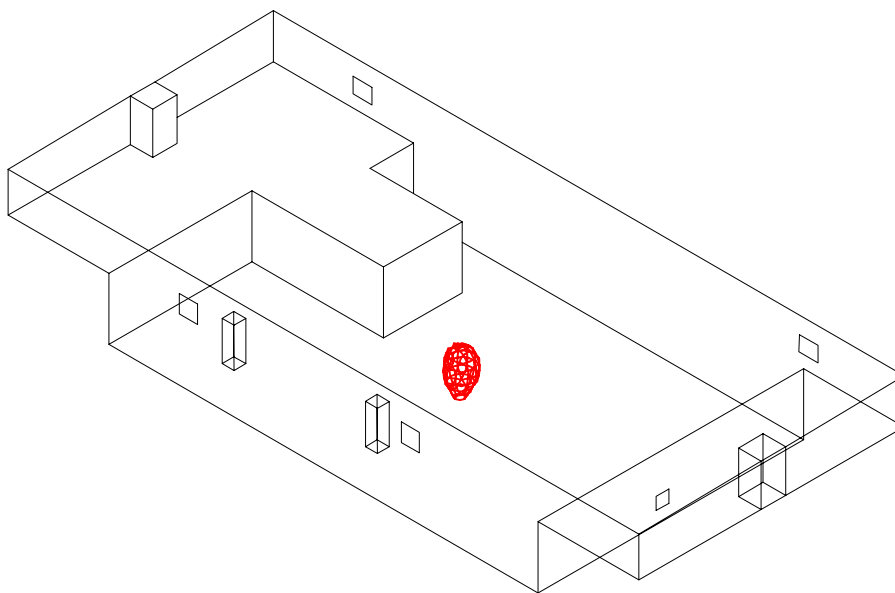
**Figure B 8 - Instantaneous release, 8 cubic feet of hydrogen, 4.1% concentration after 1 second**

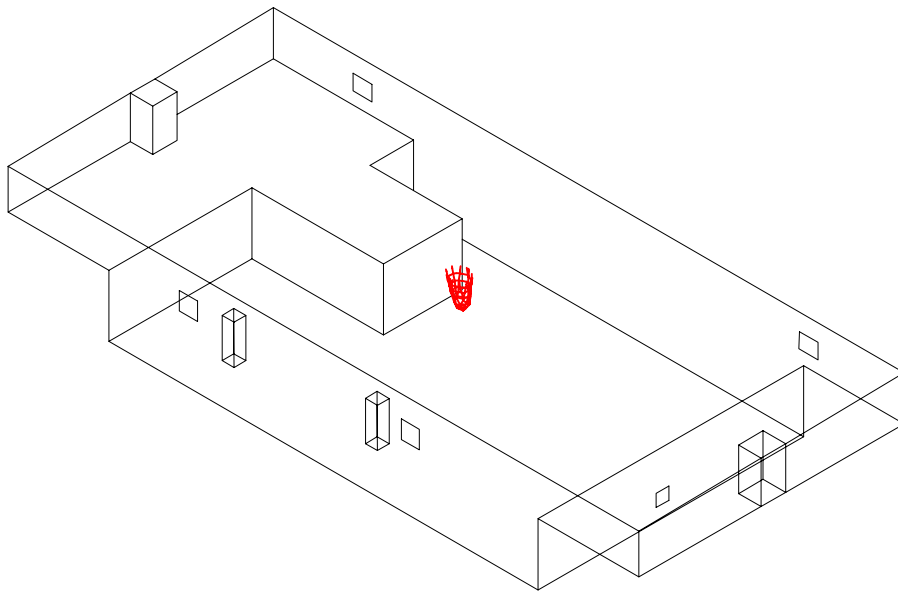
**Figure B 14 - Instantaneous release, 8 cubic feet of hydrogen, 4.1% concentration after 4 seconds**

Figures B9 and B10 show the same release at 2 seconds. Figures B11 and B12 show the same release at 3 seconds. The 4.1% hydrogen concentration cloud has risen off the floor, and is decreasing in size as it rises. Both the 1% concentration cloud (Figure B13) and the 4.1% concentration cloud (Figure B14) have reached the ceiling at four seconds. By ten seconds, the 1% concentration cloud (Figure B15) has spread over the ceiling. By seven seconds, the 4.1% concentration cloud (Figure B16) vanishes and there is no longer any burnable mixture of hydrogen and air in the enclosure.

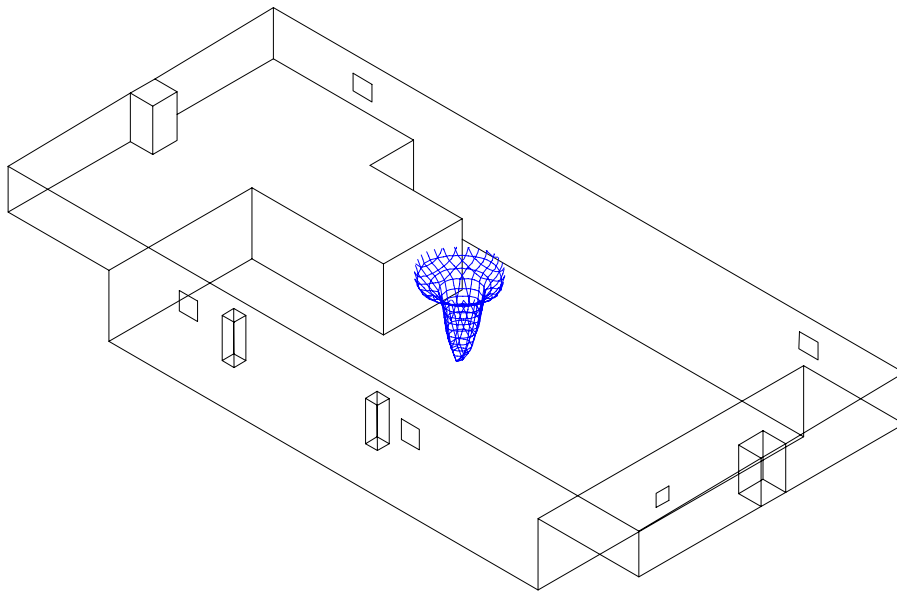
**Figure B 15 - Instantaneous release, 8 cubic feet of hydrogen, 1% concentration after 5 seconds**

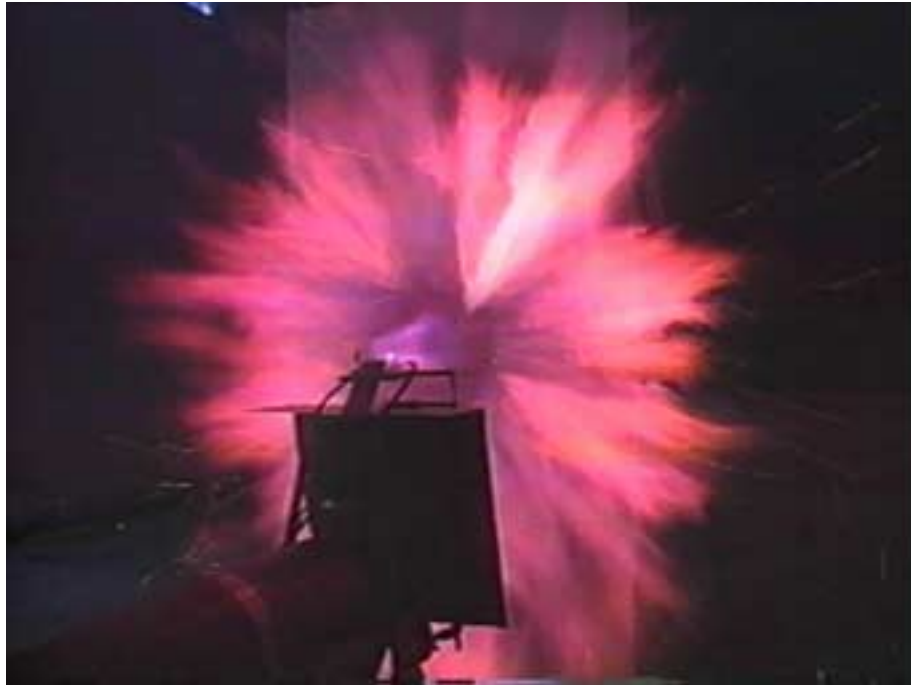
**Figure C 9 - Hydrogen flame impingement, early in burn**

The use of hydrogen fuel vehicles inside wood frame structures may result in hydrogen flame impingement on interior walls. The gypsum board that covers the wood frame can be installed in a variety of ways dependent on code requirements. Tests were run to determine the amount of damage done by hydrogen flame impingement on gypsum board mounted on two-by-four wood frames. The test utilized 1.7 pounds of hydrogen vented in 100 seconds beginning at a flow rate of 1000 SCFM. The jet was placed 2.5 feet away from the gypsum board as this distance was found to produce the maximum heat transfer in previous tests. Five tests were performed (See Table C1). Figure C8 – C10 show photos of the testing.

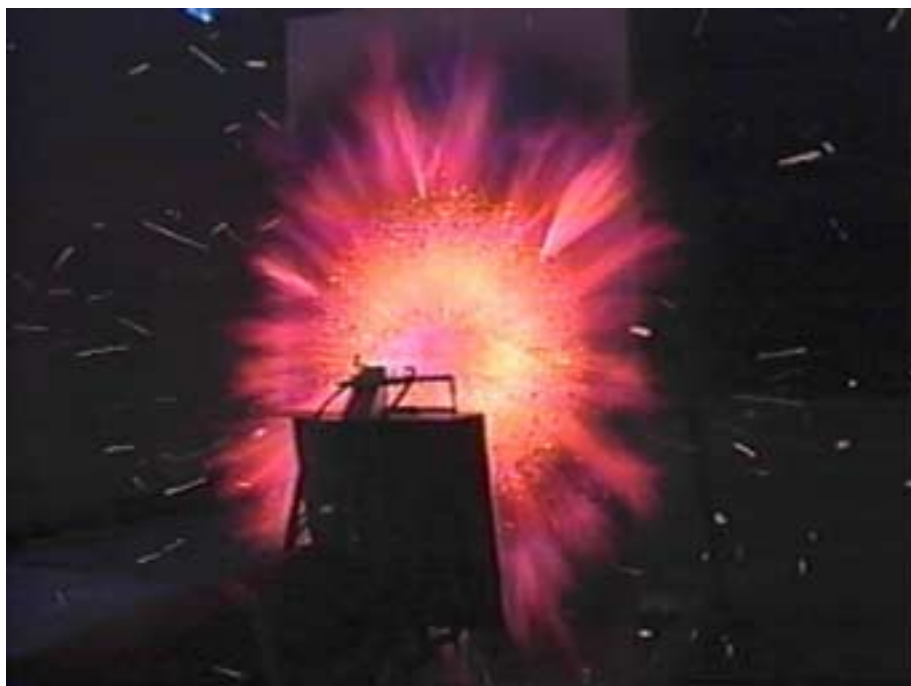
**Figure C 10 - Hydrogen flame impingement on gypsum wallboard (paper cover burning)**
